RI 9280

Leakage Across a Bituminous Coal Mine Barrier

By Noel N. Moebs and Gary P. Sames

BUREAU OF MINES

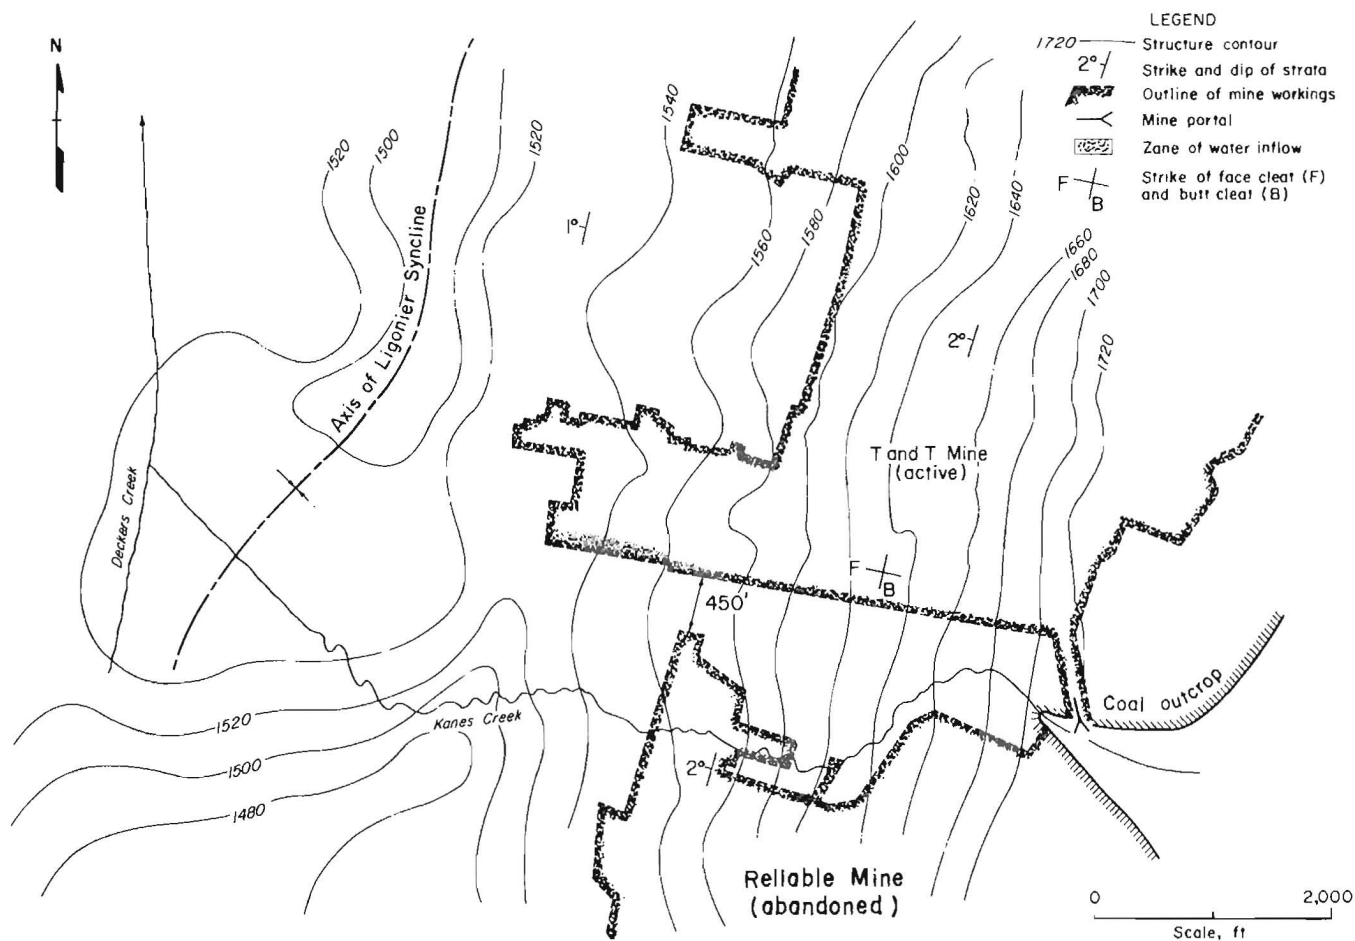
Figure 4.—Structure contours on Upper Freeport coalbed.

The coalbed is 48 to 54 in thick and dips about 2° westward towards the axis of the Ligonier Syncline (fig. 4). The principal coal cleat trends are N 10° E (butt) and N 79° W (face). Immediately beneath the coalbed is 2 ft of dark gray clay shale. The immediate mine roof normally consists of 2 to 15 ft of hard shale and shale with sandstone streaks. This is overlain by 50 to 60 ft of generally massive, coarse-grained Mahoning Sandstone. Roof rolls,

Because of the wide spacing of surface drill hole data points neither isopach (fig. 10) nor structure contour (fig. 4) maps suggested any local conditions that might account for the water. The existence of a surface diamond drill hole that passed within 100 ft of the major leakage was of little help in explaining the anomalous conditions because the driller's log was generalized and showed only a normal stratigraphic sequence and a very thick section of undifferentiated sandstone.

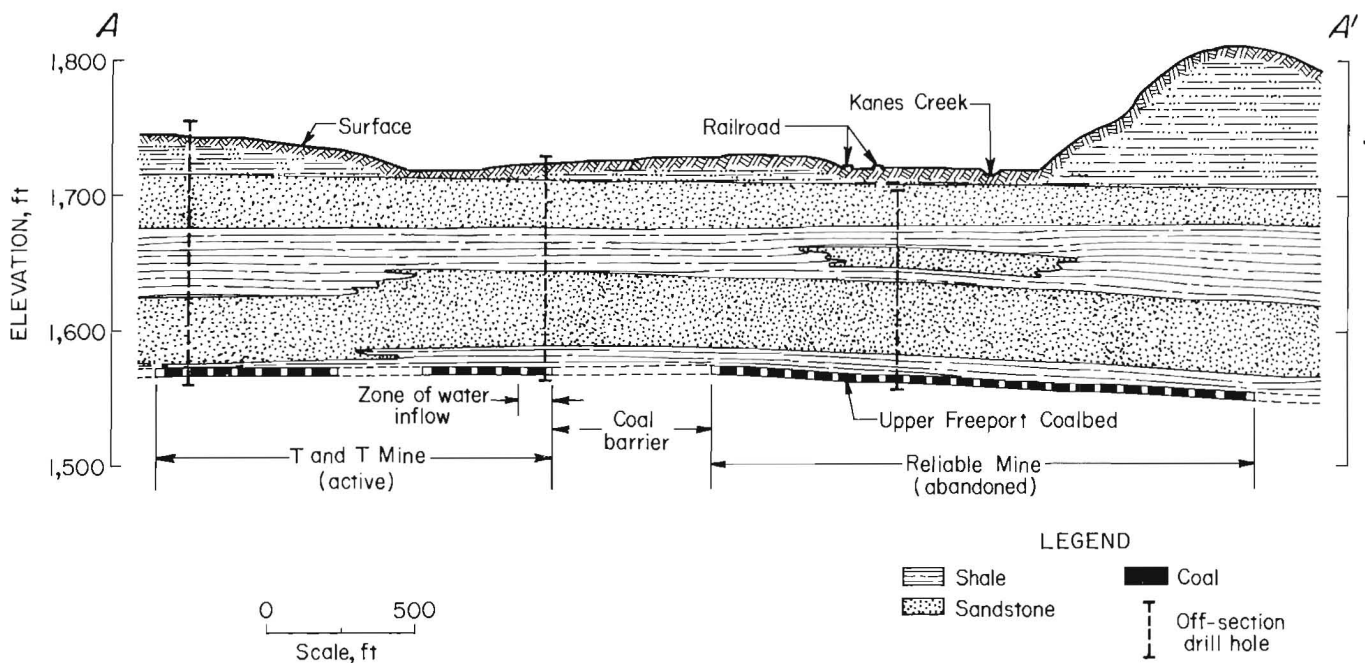
Figure 6.—Transverse profile of mine area.

The mine was opened in 1982 and developed westward, downdip, and adjacent to a flooded mine. Transverse (fig. 6) and longitudinal (fig. 7) profiles illustrate these relations. Large coal reserves lie west and downdip of the adjacent mine and access to these reserves, other than by shaft or closely skirting the adjacent mine, is limited.

In the area of closest proximity between the two mines the safety barrier was purported to be at least 450 ft wide; however, it was in this area that water was first encountered during development of the active mine. It entered the mine through roof bolt holes, with minor seepage through the coalbed. The water inflow was at first clear and pure, but gradually became acidic and discolored with iron oxides. An analysis of the water (table 3) clearly confirmed that it was acid mine drainage in contrast to ground water roof drippers from another wet portion of the mine (table 3). The adjacent flooded mine was the only likely source of such water in the vicinity, and this adjacent mine was flooded nearly to the portal, a depth of 140 ft, thus exerting a pressure of about 61 psi against the barrier.
